### A Solid Track Record of Providing Robust Protection for the Plant's High-Risk Hazards

#### Scope of the Project

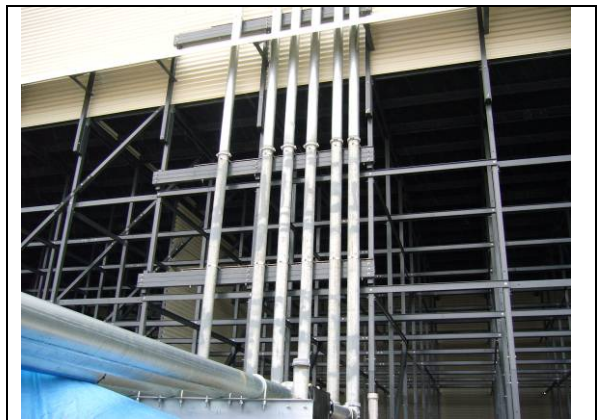
*In chemical plant applications where volatile substances are used in the manufacturing process, it is critical that structures such as cooling towers have robust fire protection systems to protect lives and valuable assets*

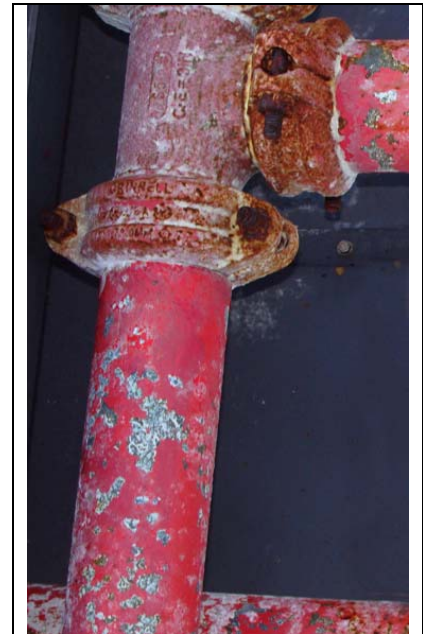
While doing maintenance work within their cooling tower, the plant had discovered an air leak on the pilot line of the fire protection system and asked F.E. Moran to repair it. It was discovered that corrosion at the joint of the pilot line had caused the leak, which led F.E. Moran to suggest inspecting the water piping. Experience told F.E. Moran that if the pilot line had sustained corrosion from the harsh environment, the water piping was probably in need of maintenance as well. F.E. Moran's speculation proved to be accurate and the plant's commitment to safety led them to make the decision to replace all of the piping in the cooling tower. The

***F. E. Moran predicted that the plant's water pipes had experienced corrosion due to the harsh environment. In a one-week timeframe they completed the installation of a new deluge system within the facility's cooling tower.***

F. E. Moran installed Schedule 40 galvanized pipe to constitute the new deluge system, which is designed to withstand severe elements to a higher degree than standard pipe. Additionally, F.E. Moran installed stainless steel nozzles for a higher degree of corrosion resistance. Another measure they took to counter the high rate of corrosion was the utilization of stainless steel hangers, which are even more durable than the galvanized hangers that previously supported the system.
