CASE STUDY

Coal-Fired
Generating Station

F.E. Moran Special Hazard Systems used their expertise, resources and efficient project management to successfully install a comprehensive fire protection system for one of the most prominent power generating stations in the Midwest.

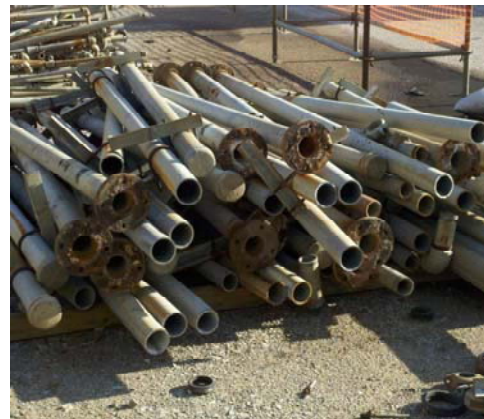
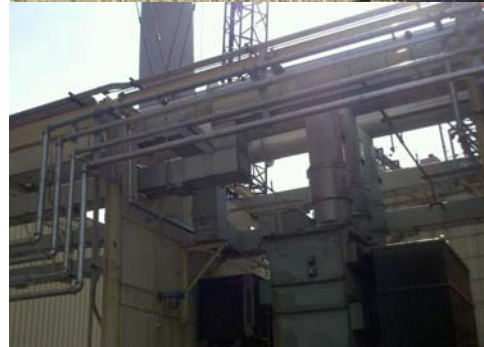
F.E. Moran removed all of the existing piping and installed a comprehensive deluge system to protect the facility's transformers

The team of skilled installers replaced four existing deluge valves that were associated with the facility's transformers. All of the existing deluge piping and supports around the transformers, including the pipe stands, were removed while retaining the current buswork protection system.

New piping was installed in a horseshoe header design, mounted above the top of the transformer shell and was supported by the steel blast fire walls. F.E. Moran Special Hazard Systems utilized Elkhart 1 ½" nozzles to provide the high level of coverage and flow density that is required to adequately protect transformers. The nozzles were positioned in a manner that the discharged water sweeps across the top of the transformer casing, creating a spray pattern that is effective and all-encompassing.

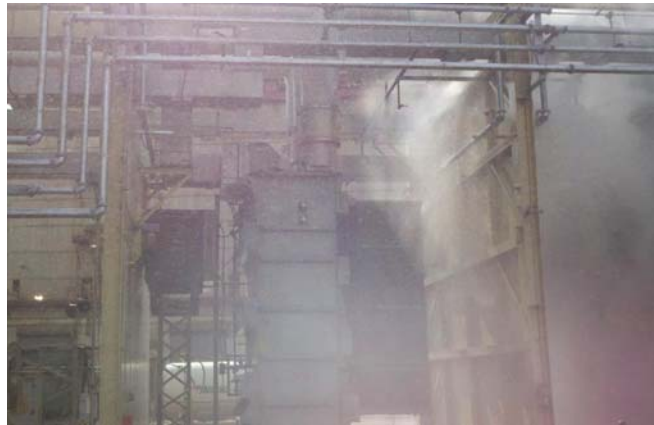
After completing the project, F.E. Moran conducted the standard hydrostatic testing of the system, as well as a flow test of the nozzles, to ensure that they had delivered a quality solution.

Following completion of the installation, F.E. Moran Special Hazard Systems conducted testing of all of the sprinkler systems to ensure that every component of the system was functioning properly. In addition to the typical hydrostatic testing that is typically executed post-installation, F.E. Moran Special Hazard Systems also performed a flow test of the nozzles for added reassurance that the system was operating at peak performance. Upon completion of the tests, there were still two days remaining in the outage, meaning F.E. Moran Special Hazard Systems finished the installation, as well as the additional auxiliary transformer, two days before their deadline.
